Case Study – The Essential Seal, AirScrape®, TailScrape®, K-Sure® Belt Support, K-Containment® Seal

The Essential Seal Solution

Conveyor Skirting & Transfer

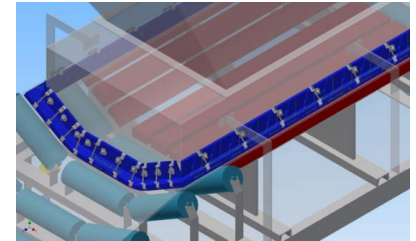
Following a comprehensive site inspection by **Richard Hodey, Area Field Technical Representative**, identified a 4m drop from the chute to transfer point, followed by thorough screening at 15mm, 5mm and then 4mm intervals.

No wear liner was used inside the chute and surprisingly ordinary 150mm rubber strips served as the chutes only form of sealing. The screening process resulted in unpleasant, disruptive, and costly material spillage, precisely 10 tonnes per week.

Other major observations noted for site rectification was insufficient belt support at the critical impact zone and further down belt sagging between the rollers was evident.

Kinder’s essential transfer optimisation solution is comprised of **AirScape®, TailScape®, K-Sure® Belt Support System** and **K-Containment® Seal**. This industry benchmark and first of its kind solution was devised and installed to provide optimal skirting and sealing at the site’s high impact zone and more specifically to eliminate the costly and hazardous material spillage problem identified during site inspection.

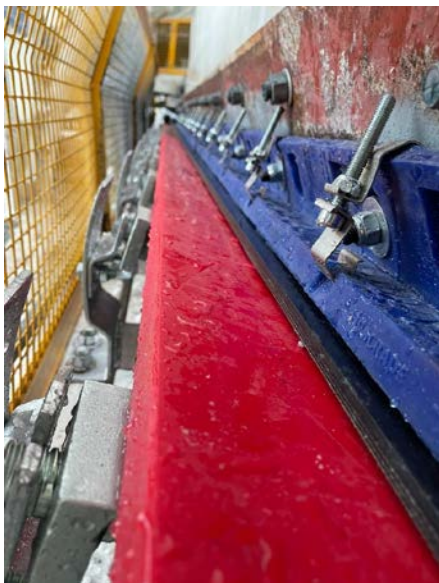
Left Photo:

Essential Seal Installation, consisting of **AirScrape®, TailScrape®, K-Sure® Belt Support System and K-Containment® Seal.**

Site maintenance now report maintenance time and resources devoted to removing 10 tonnes of spillage is no longer required, labour and product loss reductions targets will soon be achieved.

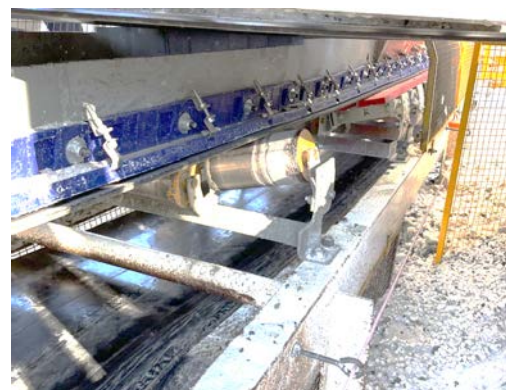
Spillage was a major challenge faced by the processing plant; this was successfully resolved through the installation of Kinder’s essential transfer point solution.

Sites maintenance now report maintenance time and resources devoted to removing 10 tonnes of spillage is no longer required, labour and product loss reductions targets will soon be achieved.
