Case Study – FRAS Airscrape®, Tailscrape and K-Containment® Seal

Kinder Australia Product:	FRAS <u>Airscrape®</u>, <u>Tailscrape</u> and <u>K-Containment®</u> Seal
Product Category:	Conveyor Skirting & Sealing
Location:	Queensland
Conveyed Materials:	Wheat and barley
Belt Width / Belt Speed:	900mm / 3.5 m/sec
Installation Date:	January to April 2023

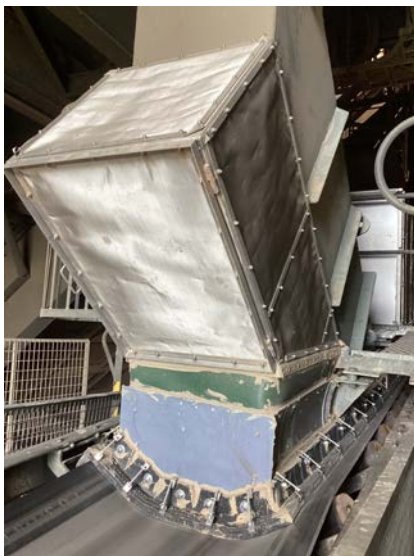
Due to high material drop at the transfer chute an excessive amount of dust and spillage was observed. Faced with the ongoing dust and spillage predicament, the Maintenance Supervisor specifically sought a low maintenance, long lasting solution to suppress and minimise the excess dust/spillage at the facilities outdated tail end transfer chutes.

To elaborate, the 10-metre material drop created a high material flow pressure at the end of the chute at the drop zone of the receiving conveyor. Excessive dust was shooting out at the front of the old, enclosed tunnel, like out of a "barrel of a gun". Additionally, due to the presence of wheat and barley dust and the associated fire/explosion risk, it was a requirement for all conveyor components to be anti-static and FRAS-approved.

The operator previously relied on double sealing skirtings which were worn through, the chute set up was also outdated and well due for an overhaul.

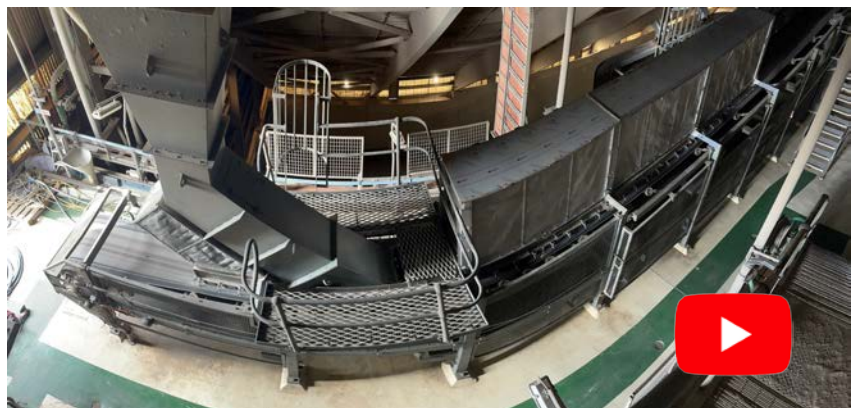
AFTER PHOTOS:

Kinder's FRAS AirScrape®/TailScrape/K-Containment® Seal skirting solution successfully contained the excess dust and spillage is now down to zero.

Between January and April 2023, the installation process began, this entailed modifications to the drop zone to divert the grain/barley to be more centrally loaded. The site skirting was also modified to accommodate Kinder's FRAS **AirScrape®** (10m), FRAS **TailScrape** (1m), and FRAS **K-Containment® Seal** (6m) and extension of the existing chute tunnel and custom made Dustboxes. Behind the drop chute, the Tailbox was extended by 1-metre. Stainless steel filter cloth was also installed onto the Tail Dustbox.

With the reduction in air pressure, dust and/or material was no longer able to escape from the Tail box. Excessive air pressure gets released through the filter cloth, the dust stays inside the box and drops back into the material flow.

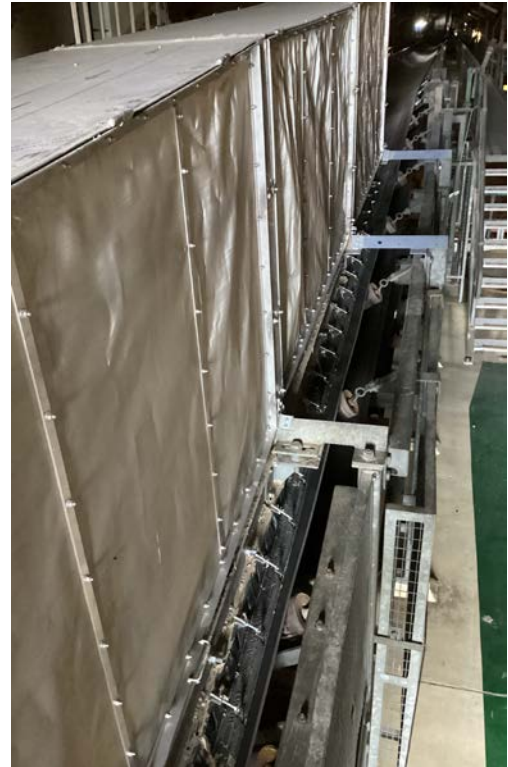
ABOVE PHOTO:

FRAS conveyor skirting and dustbox combination eliminates dust/spillage plus the fire/explosion risks at the transfer chute load zone is greatly minimised.

In front of the chute tunnel, a 6-metre long, 1.2-metre high and 0.6-metre-wide a custom-made Dustbox with stainless steel filter cloth was also installed. The filter cloth is vertical, left and right side of the Dustboxes, nothing on the top, the end and the front of the Dustbox. Inside the Dustboxes, 5 dust barriers and curtains were installed to further calm down and suppress the excessive dust clouds. Similar to the Tailbox, the excessive air pressure gets released through the vertical stainless steel filter clothes, dust is successfully contained inside the Dustbox and drops back into the material stream.

AirScrape® and TailScrape, highly effective contactless skirting solution makes no contact with the belt surface with its unique diagonal arrangement of hardened lamellas, air is led from the outside into the middle of the belt, creating a powerful suction effect enabling fine dust particles to remain in the conveyor section.
