Case Study – The Essential AIR Seal – Dust Containment Combination

Kinder Australia Product:	<u>AirScrape®</u>, <u>TailScrape</u>, <u>K-Sure®</u> & <u>K-Containment® Seal</u>
Product Category:	Conveyor Skirting & Transfer
Location:	Brisbane, QLD.
Conveyed Materials:	Cement Production Materials (Clinker, Sand and Gravel)
Conveyor Belt Width / Speed:	1200mm Belt Width / 1.5 m/sec
Installation Date:	December 2021

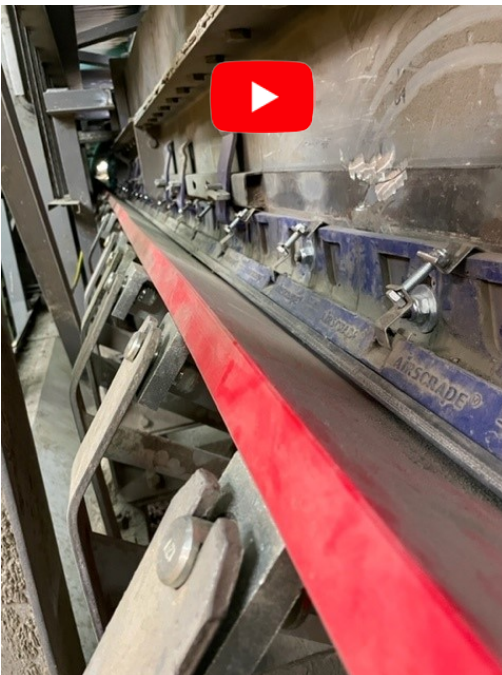
Photo: Problem free transfer point, dust and spillage reduced by 98% after installing AirScrape®, TailScrape, K-Containment® Seal & K-Sure® Belt Support System.

Extremely satisfied with the outcomes achieved at this transfer point, the operator welcomed the implementation of **The Essential AIR Seal – Dust Containment Combination** - phase 2 recommendations. This entailed a few necessary adjustments before the installation of **AirScrape®**, **TailScrape** and ceramic **K-Containment® Seal** was installed and fully operational within the chute area.

To ensure maximum performance of AirScrape®, **K-Sure® Belt Support System**, a vital component of the overall solution was installed in order to avoid the issues of belt sag between the impact rollers.

A smooth straight and flat belt surface kept the AirScrape® lamellas continuously in the right position with no physical belt contact. TailScrape, worked synergistically with AirScrape® and provided outstanding sealing at the rear and K-Containment® Seal delivered on its promise as the first line of defence and effective against dust and spillage.

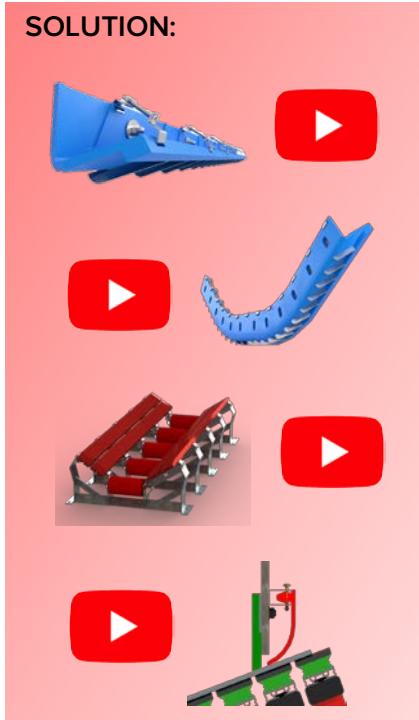
Adjustable roller frames were also used in front of the tail pulley to better align the belt from the tail pulley towards the tail chute.

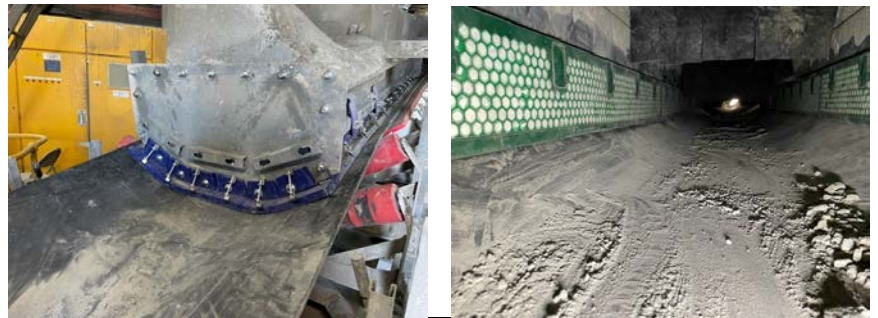
Photos: After Installation of TailScrape (L) and K-Containment® Seal (R)
